# ***2007 SAMPLE REPORT***

***Predictive Maintenance Services***

***Infrared/Thermal Analysis***

# ***INFRARED/THERMAL ANALYSIS***

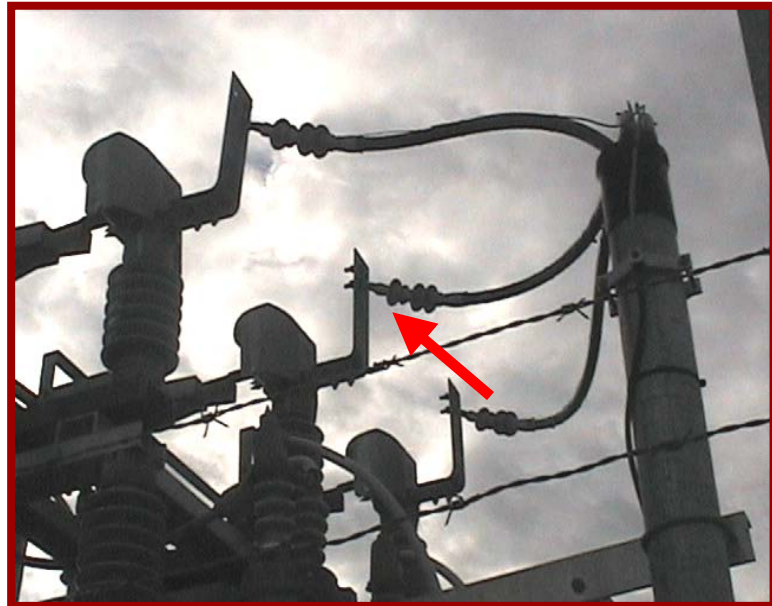
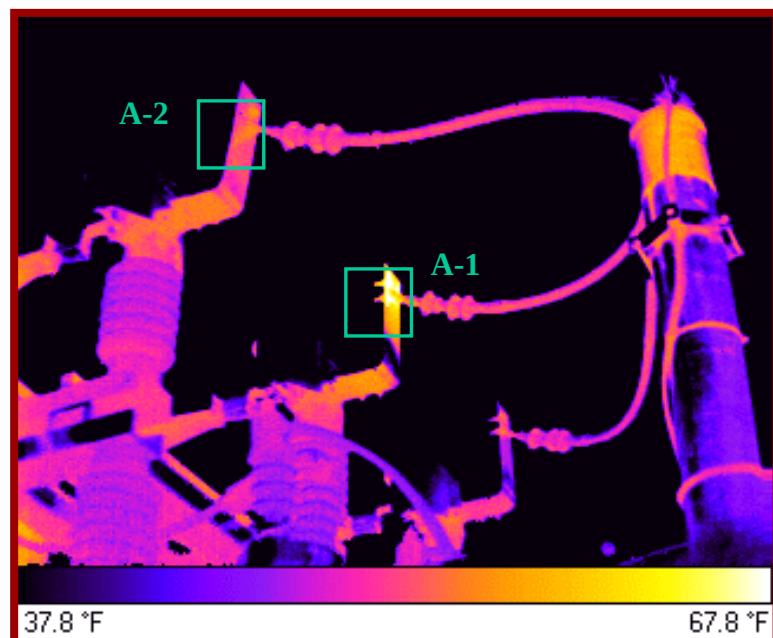
**INVENTORY NO. 004**

**EQUIPMENT:** North Cap. Bank Yard Center Phase  
Buss-to-Underground Feeder Connection.

**FINDINGS:** Suspect loose deteriorated Buss-to-Underground Feeder Connection

**EXCEPTION TEMP. (Area.1):** 71F

**REFERENCE TEMP. (Area 2):** 50F

**DELTA-T:** 21F

**PRIORITY 2**

**RECOMMENDATIONS:** Inspect, clean, and tighten center phase buss connector and all related components.

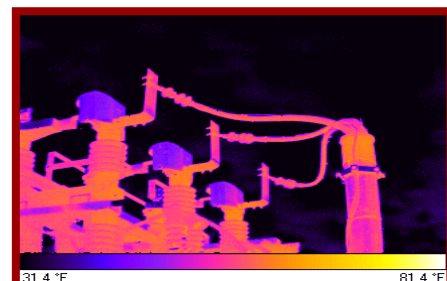
**Notes:** Normal Thermograph of South Bank

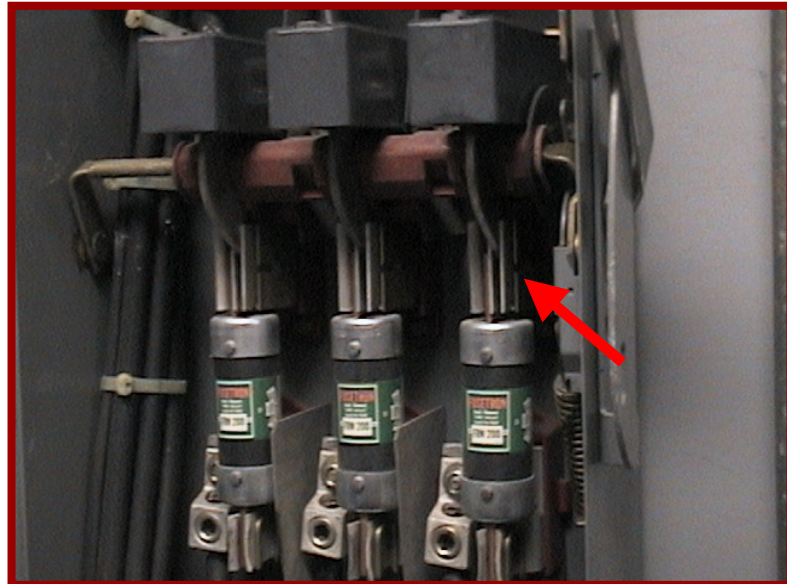
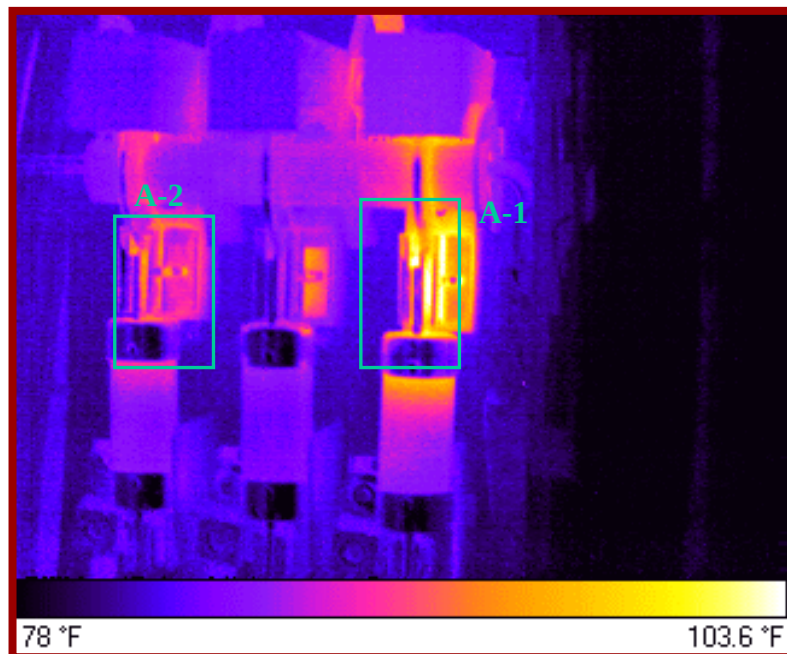
**INVENTORY No. 024**

**EQUIPMENT:** Panel LRMA Main Disconnect Right  
Phase Top Fuse Holder

**FINDINGS:** Suspect loose deteriorated fuse holder  
components and contacts.

**EXCEPTION TEMP. (Area.1):** 107F

**REFERENCE TEMP. (Area 2):** 85F

**DELTA-T:** 22F

**PRIORITY 2**

**RECOMMENDATIONS:** Inspect, clean, and tighten  
fuse assembly and related components. Replace fuse and  
components if required.

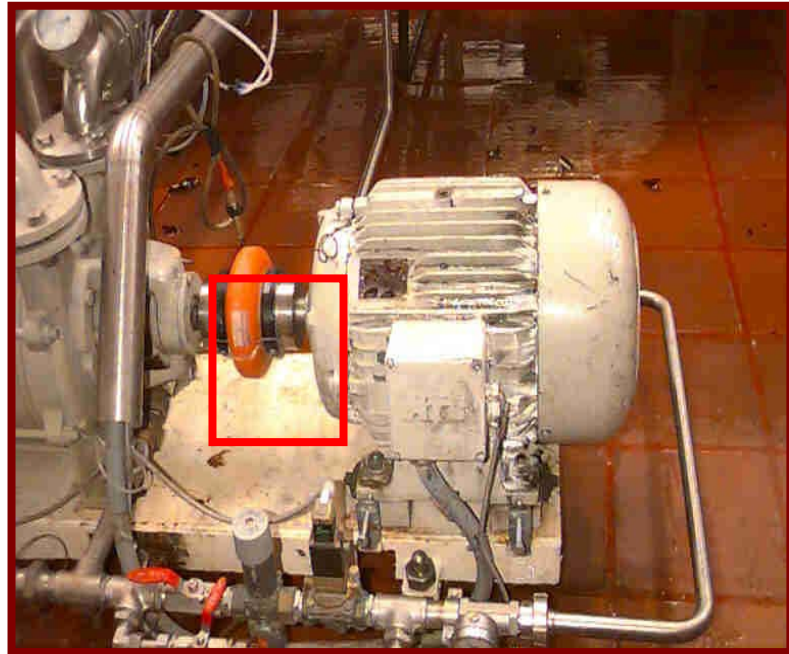
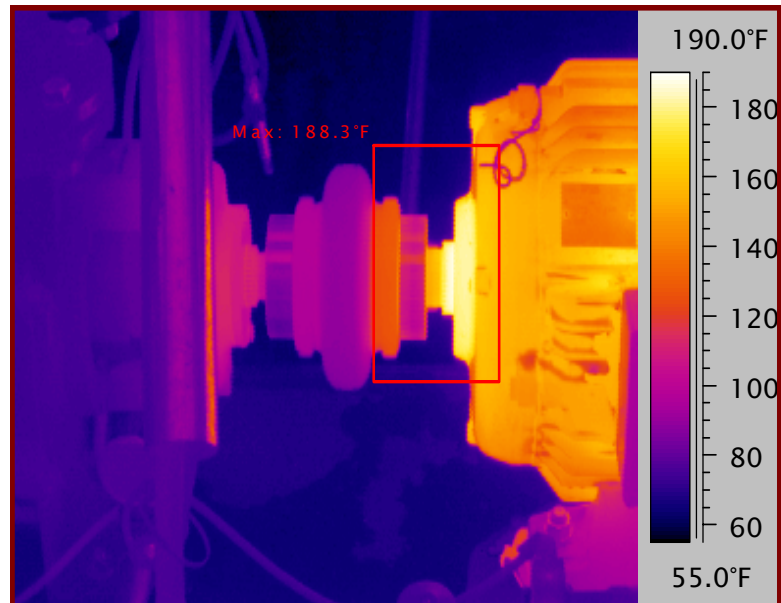
**INVENTORY No. 027**

**EQUIPMENT:** Plant No.1 Main Pump  
Line No.1

**FINDINGS:** Uneven thermal pattern on coupling & End-Bell temperatures exceed maximum rise.

**EXCEPTION TEMP. (pt.1):** 188F

**REFERENCE TEMP. (pt.2):** 170F

**DELTA-T:** 18F

**PRIORITY 1**

**RECOMMENDATIONS:** Inspect load, shaft alignment and lubrication and comply with manufacturers specification.

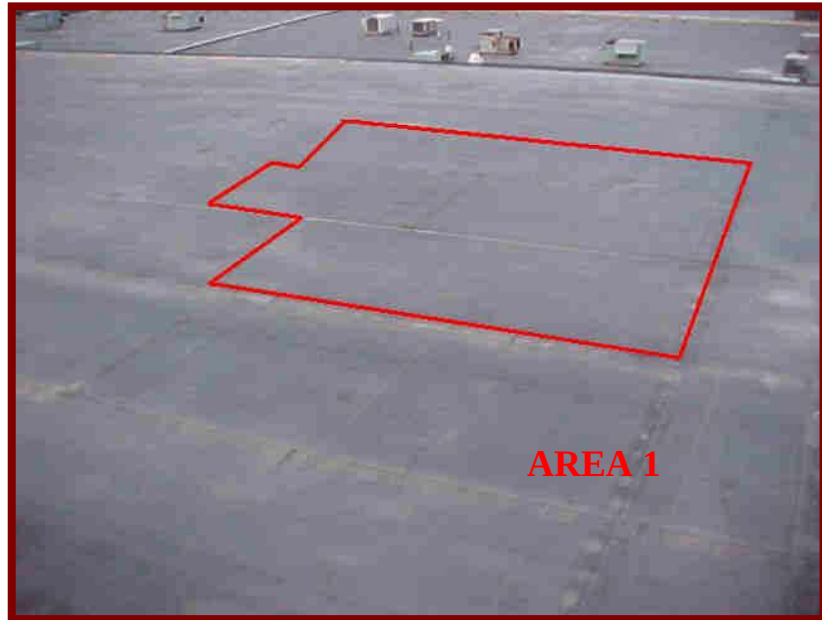
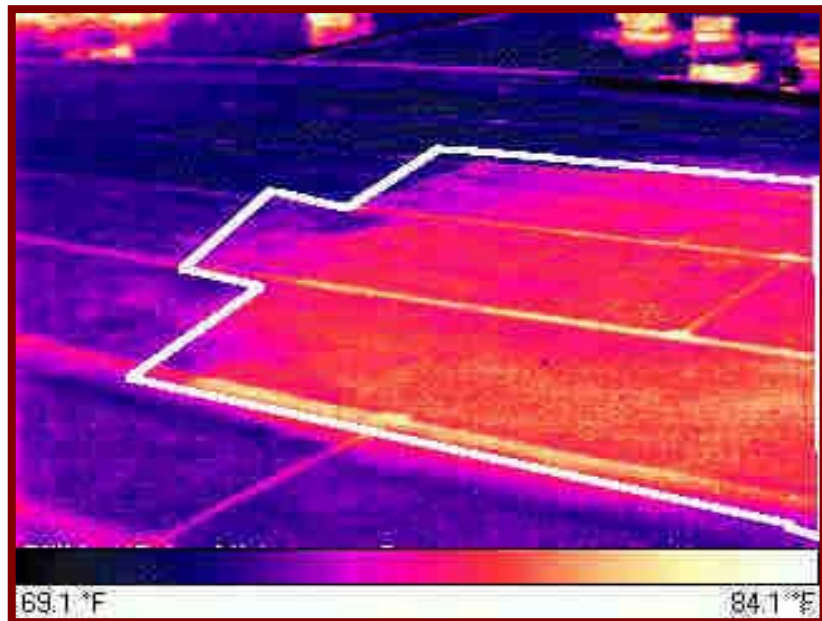
**AREA 1**

**EQUIPMENT:** Front Office (Area 1)

**FINDINGS:** Built-Up Construction

A continuous semi-flexible roof coverings of laminates, or piles, of saturated or coated felts alternated with layers of bitumen. Surfaced with asphalted materials.

**RECOMMENDATIONS:** Consult with an experienced roofing contractor to confirm results. (Core samples are suggested to confirm thermal analysis).

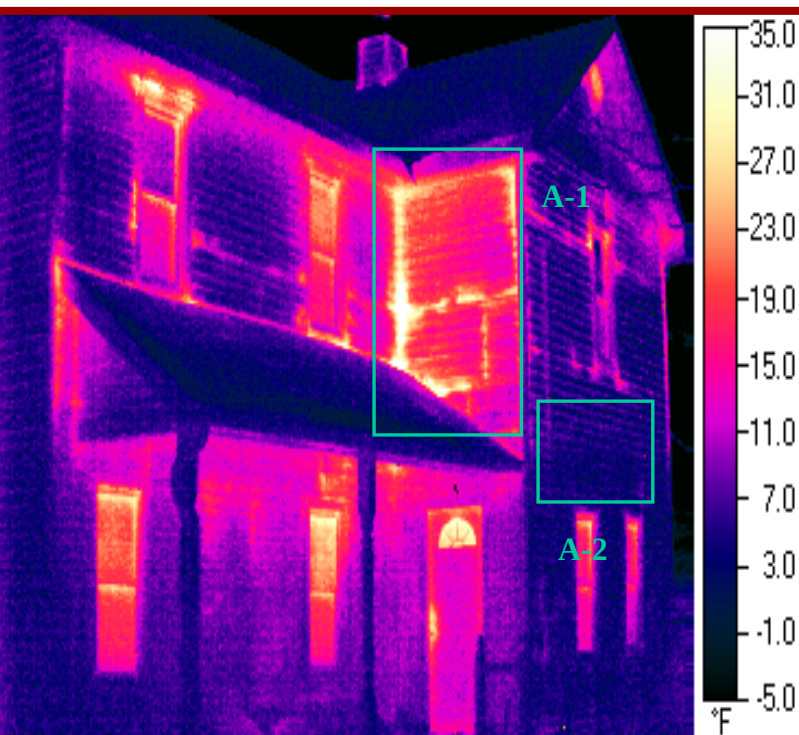
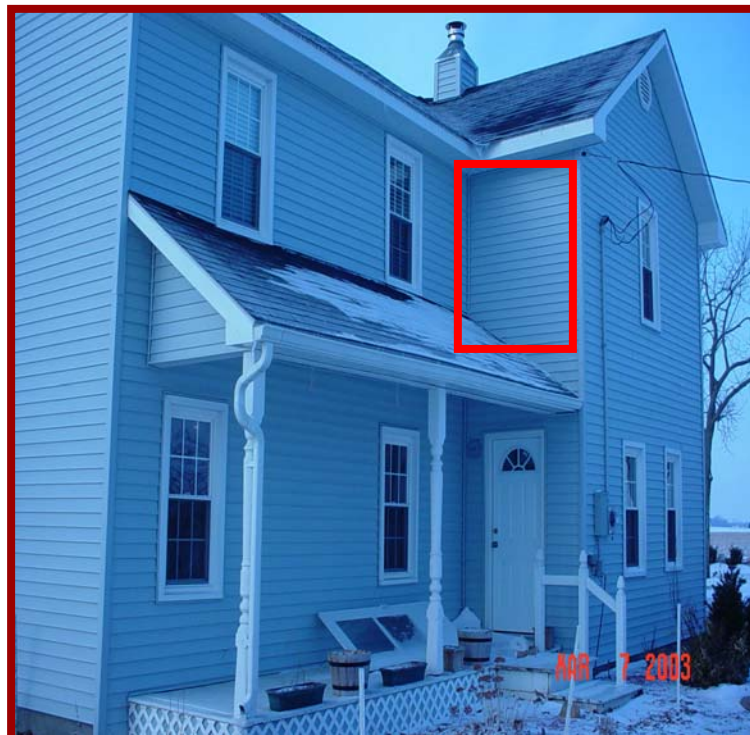
**LOCATION:** North End East Side (above porch)

**EQUIPMENT:** Vinyl Siding

**FINDINGS:** Suspect Thermal Loss due to lack of insulation and/or excessive air flow.

**EXCEPTION TEMP. (Area.1):** 37F

**REFERENCE (Normal) (Area 2):** 12F

**DELTA-T:** 25F

***Indicates major discrepancy; repair immediately.***  
**PRIORITY 3**

**RECOMMENDATION:** Further inspect the area of loss and repair as required.

Further inspections should be completed by a professional builder or at the home owners own risk!

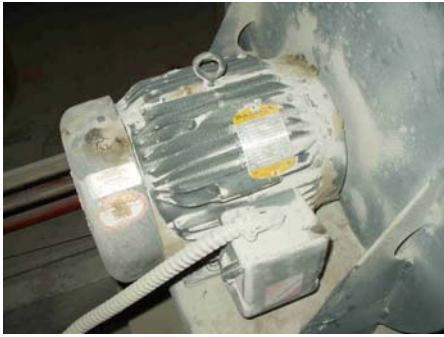
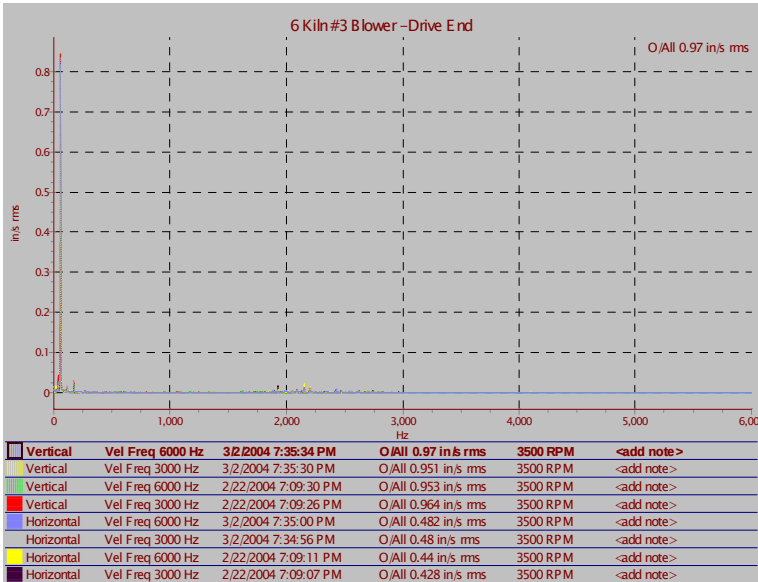
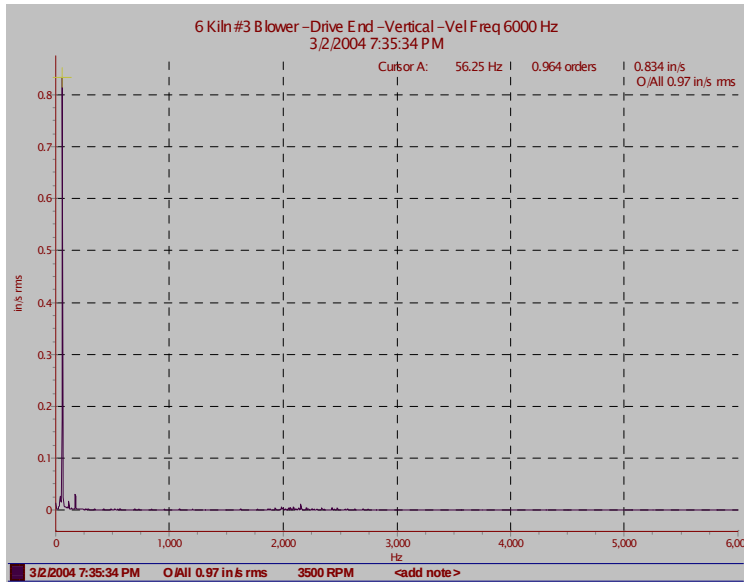
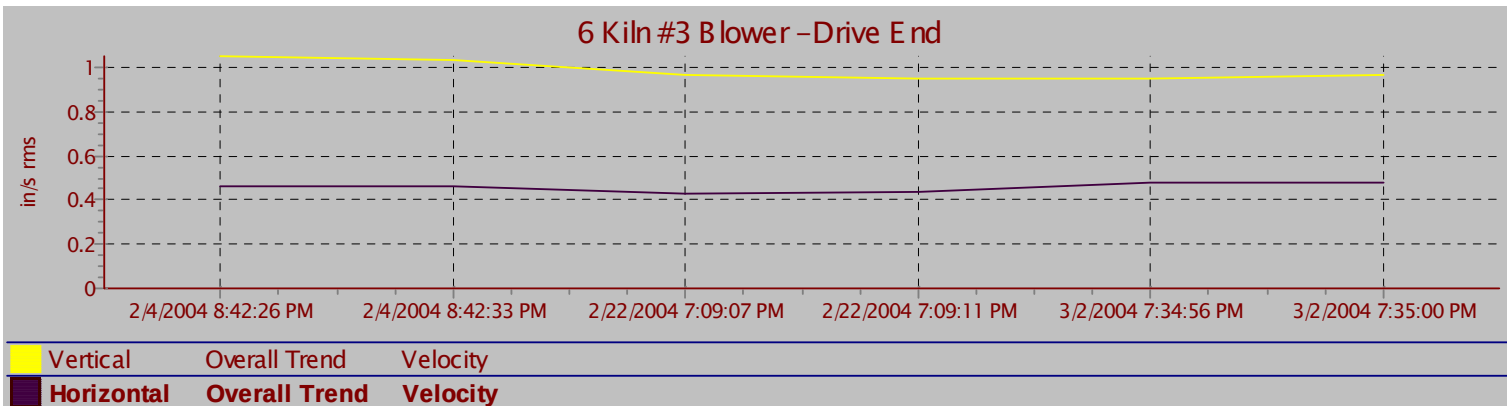
## 6 Kiln #3 Blower Motor

**Findings:** Overall amplitudes are high @ 0.97 in/sec. rms.. Condition indicates mass unbalance and/or misalignment.

**Recommendations:** Have motor PM'd and balanced during next 30 days.

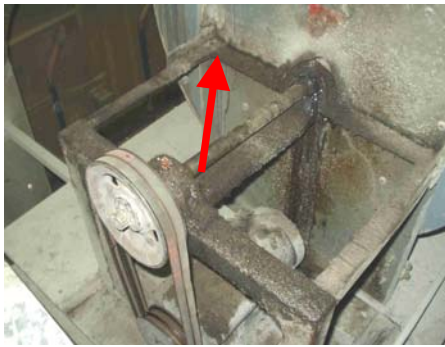
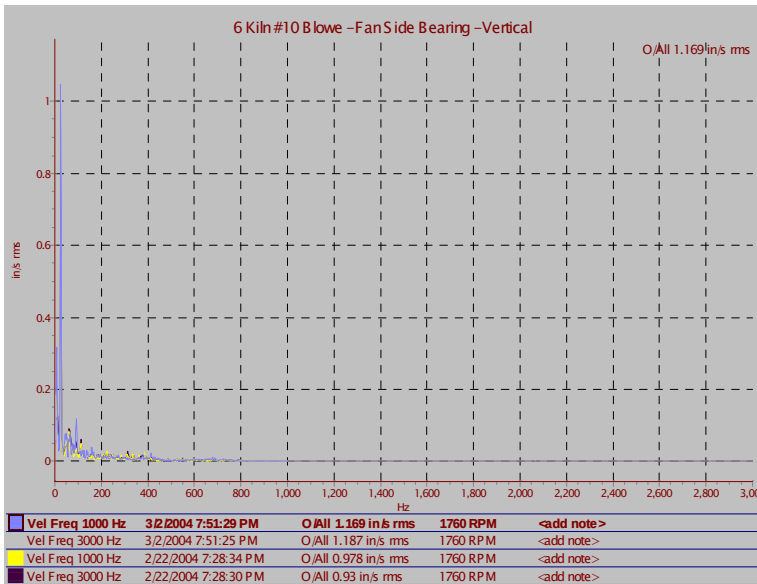
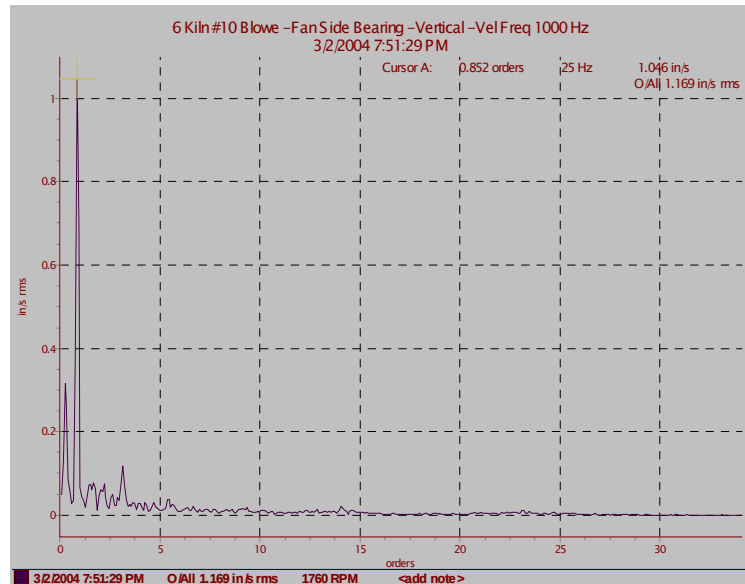
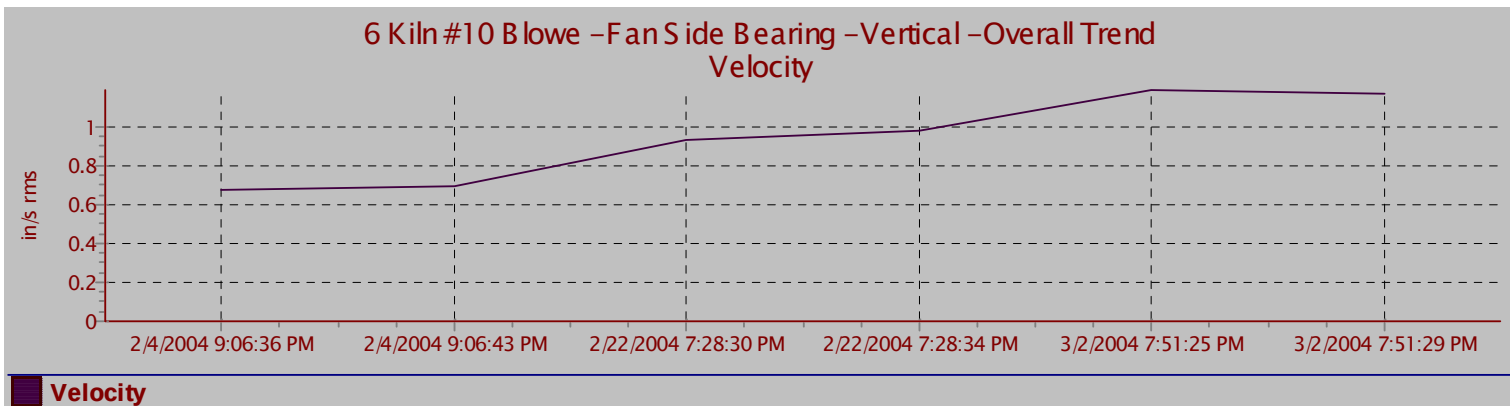
## 6 Kiln #10 Blower Motor & Bearings

**Findings:** Overall amplitudes are high @ 1.169 in/sec. rms.. Structure is visibly damaged and causing shaft & fan blades to make contact with hood.

| <b>Machine Name</b> | <b>Priority Code</b> | <b>Problem Description</b> |
|---|---|---|
| 6 KILN #10 BLOWER/ MOTOR | 1 | Structural Looseness |

**Recommendations:** Have structure repaired immediately.

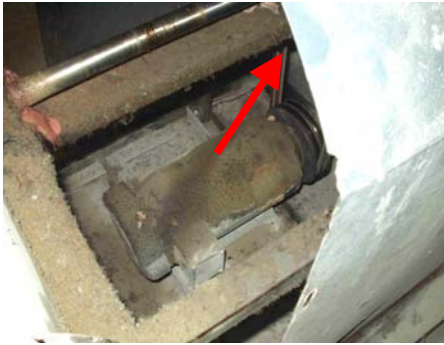
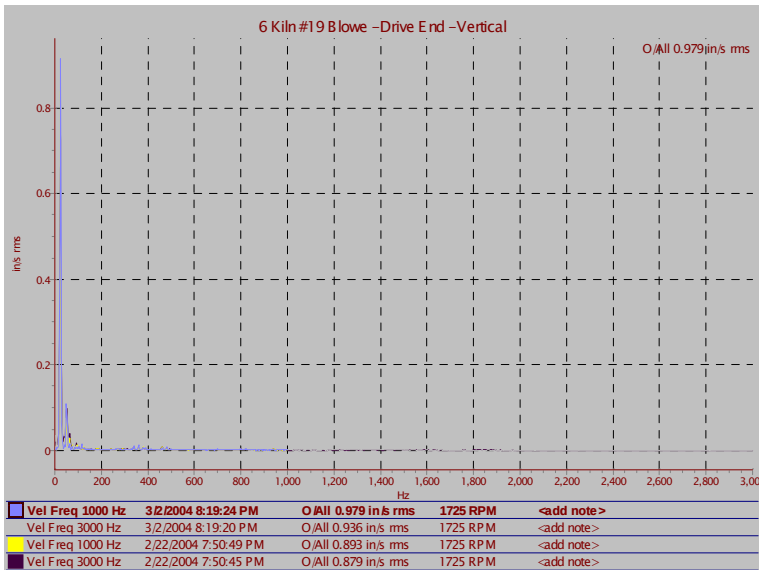
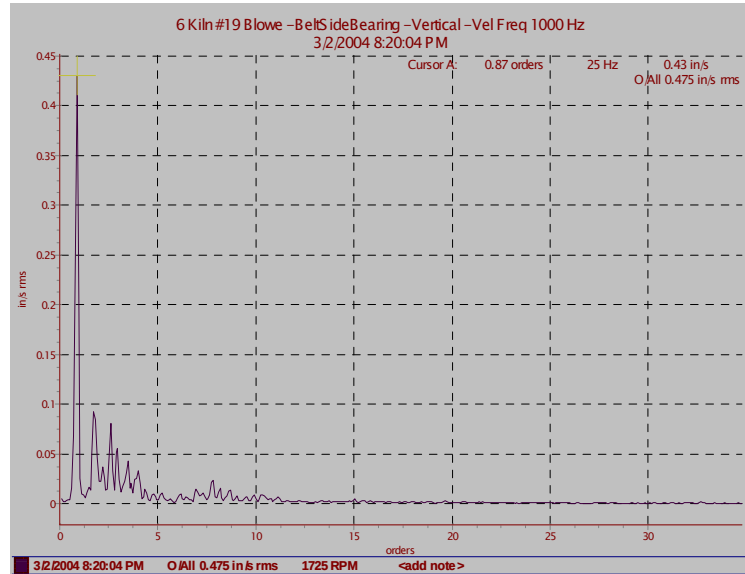
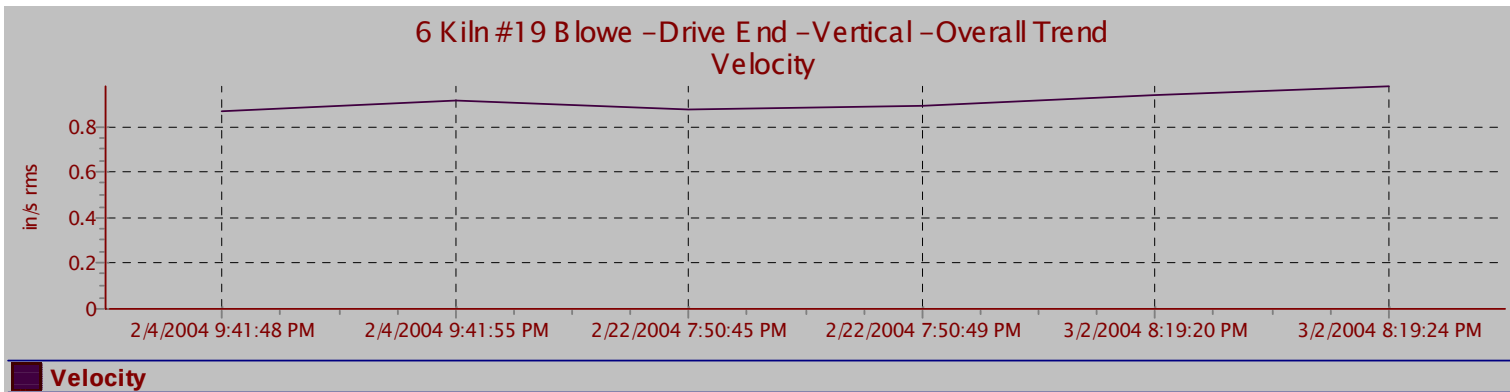
## 6 Kiln #19 Blower Motor & Bearings

**Findings:** Overall amplitudes are high in (0.979 in/sec. rms. ). Probable unbalance on motor and/or improper belt tension and/or eccentric pulley.

| <b>Machine Name</b> | <b>Priority Code</b> | <b>Problem Description</b> |
|---|---|---|
| 6 KILN #19 BLOWER/ MOTOR | 2 | Motor Unbalance/ Improper belt tension/ Eccentric pulley |

**Recommendations:** Have motor PM'd and balanced. Check belt tension and inspect pulley during next 30 days.

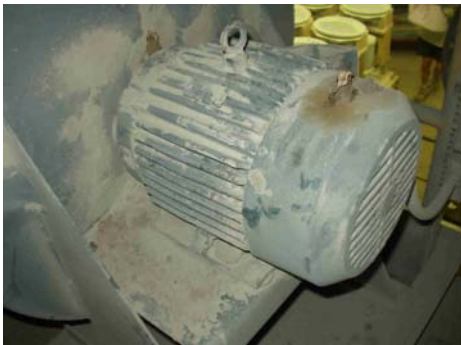
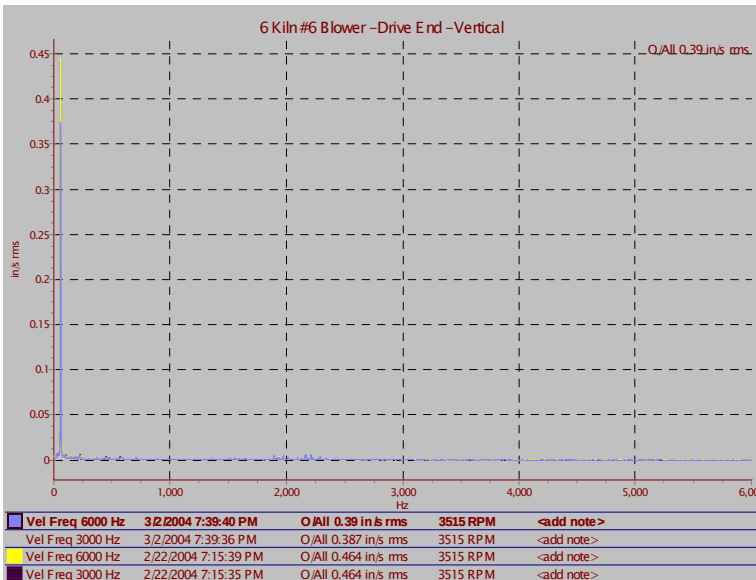
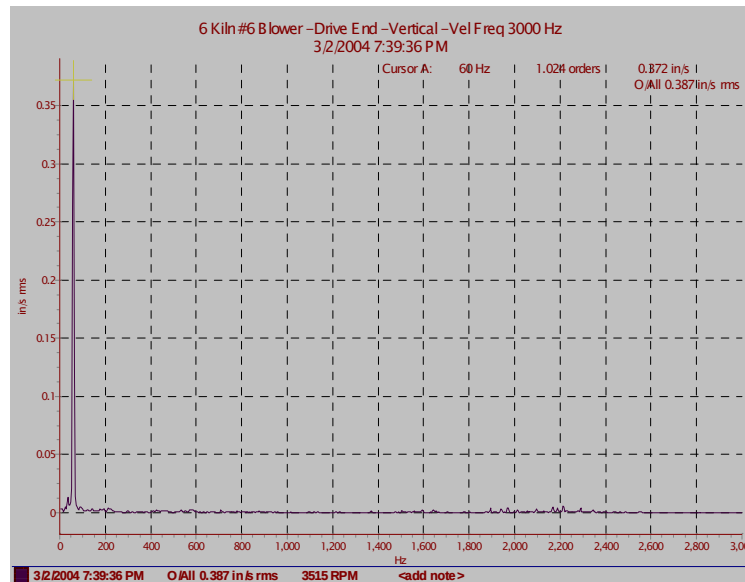
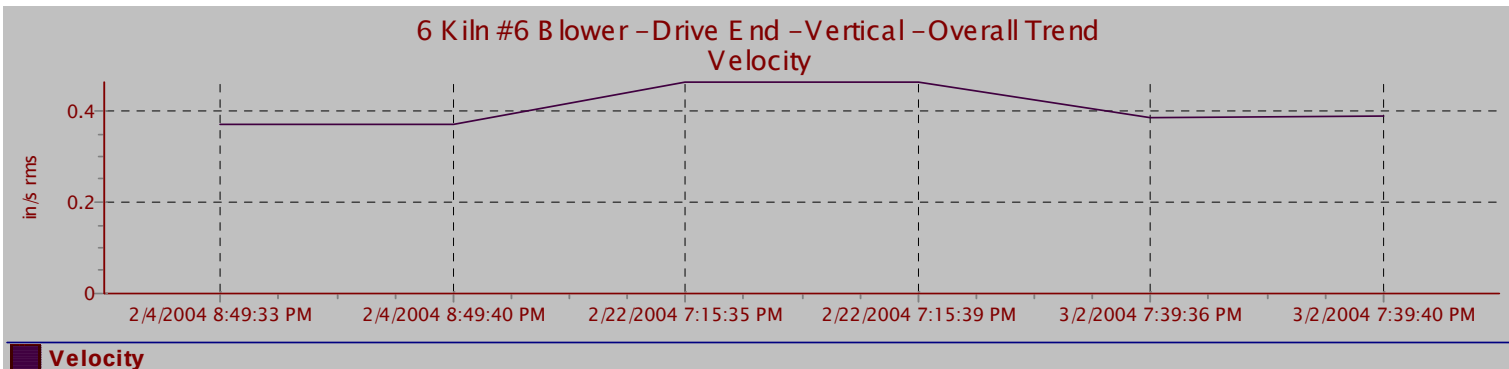
## 6 Kiln #6 Blower Motor

**Findings:** Overall amplitudes are @ 0.372 in/sec. rms.. Indicates mass unbalance and/or misalignment. Condition not considered serious @ this time. Continue to monitor.

**Recommendations:** Schedule equipment for proactive repair. Begin to monitor for any changes in noise or heat.

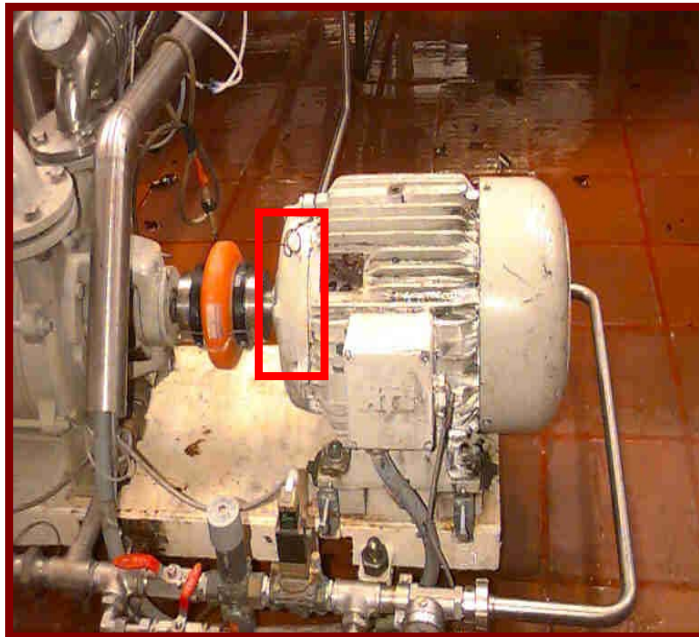
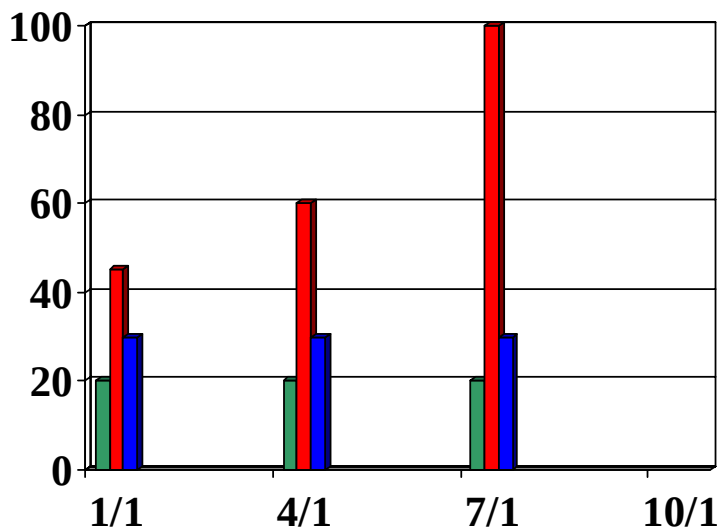
*Indicates probable deficiency; repair  
as time permits.*

**PRIORITY 2**

**Decibel Max** 100 dB

**RECOMMENDATIONS:** Lubricate bearing to proper specifications and inspect using non-destructive testing. If problem persist replace bearing.

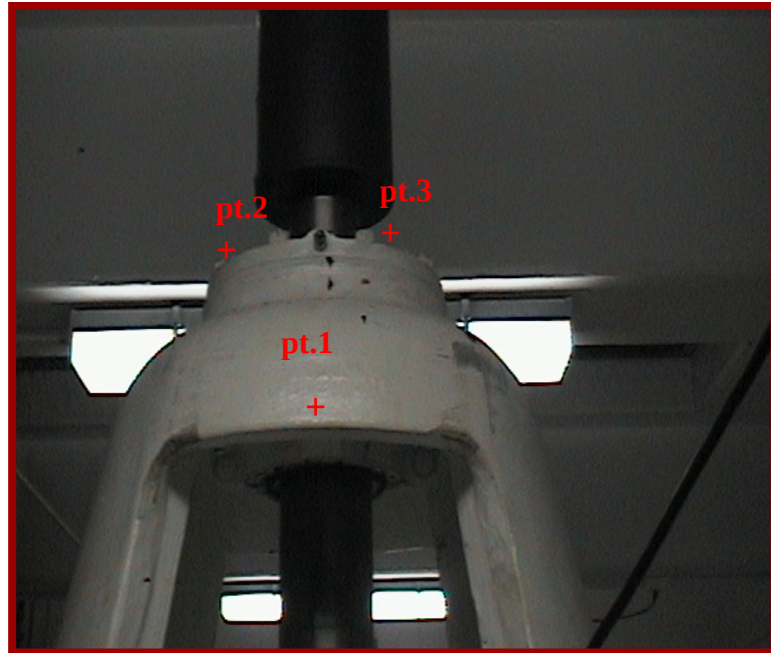
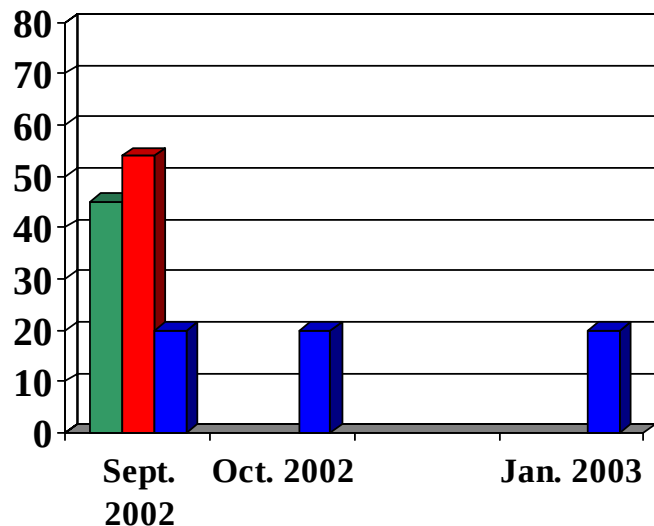
**PRIORITY RATING: (NETA STANDARDS)**  
***BASELINE READINGS***

**PRIORITY OK**

**Decibel Max** 56 dB

**(Failure Prediction@ 75dB)**

**RECOMMENDATIONS:** None
