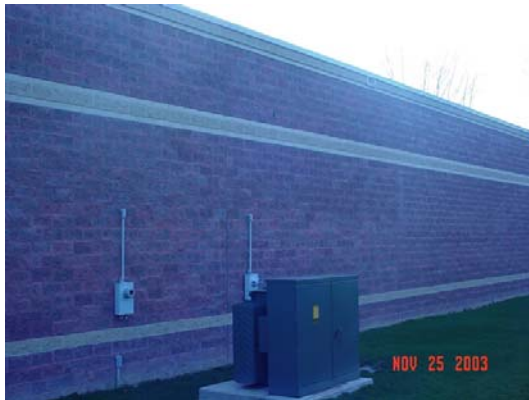
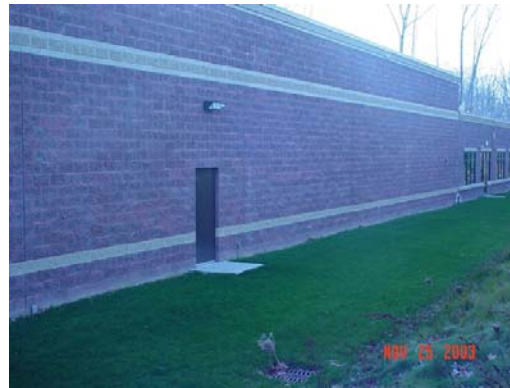
**Exterior Type:** 12" Split Face Block

**Interior Temperature:** 65F

**Outside Temperature:** 24F

**Winds:** South/West +/- 10mph.

**Side:** West End

**Findings:** Normal thermal loss around doors, windows & vents.

Thermal variation shows horizontal reinforcing bond beam.

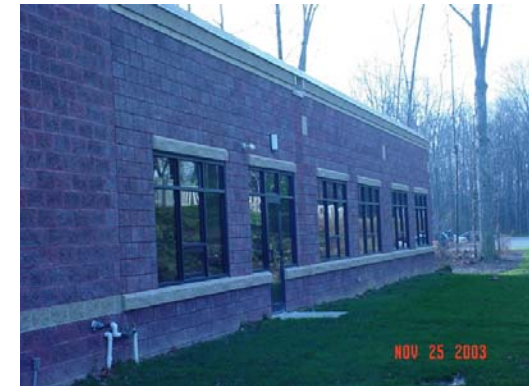
**Exterior Type:** 12" Split Face Block

**Interior Temperature:** 65F

**Outside Temperature:** 24F

**Winds:** South/West +/- 10mph.

**Side:** West End

**Findings:** Normal thermal loss around doors, windows & vents.

Thermal variation shows internal vertical reinforcement.

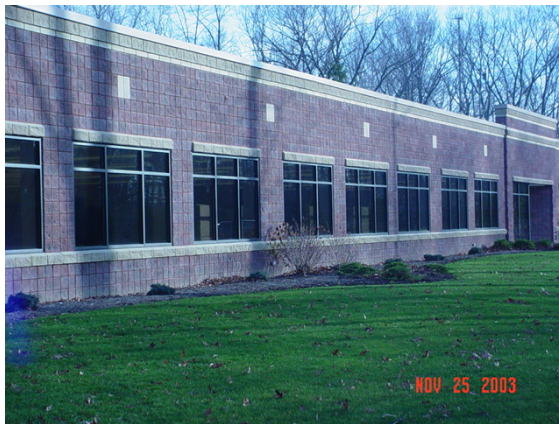
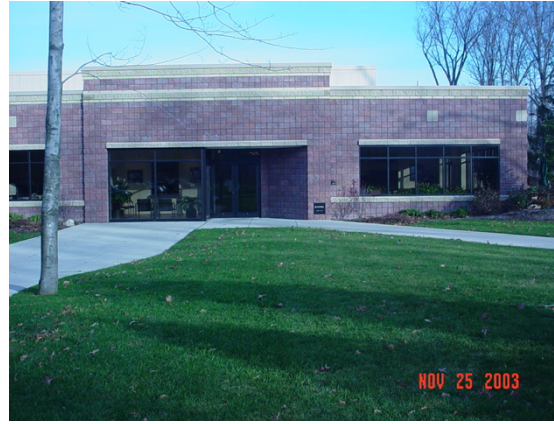
**Exterior Type:** 8" Split Face Block

**Outside Temperature:** 24F

**Winds:** South/West +/- 10mph.

**Side:** South End

**Findings:** Normal thermal loss around doors, windows & vents.

Thermal variation shows horizontal reinforcing bond beam.

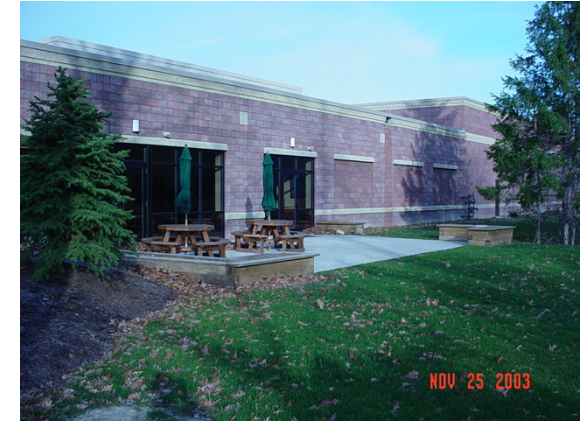
**Exterior Type:** 8" Split Face Block

**Interior Temperature:** 65F

**Outside Temperature:** 24F

**Winds:** South/West +/- 10mph.

**Side:** South End

**Findings:** Normal thermal loss around doors, windows & vents.

Thermal variation shows internal vertical reinforcement.
